SALINAS RURAL FIRE DISTRICT TAILBOARD SAFETY SESSION APRIL, 2005

Vehicle Fires & Projectiles

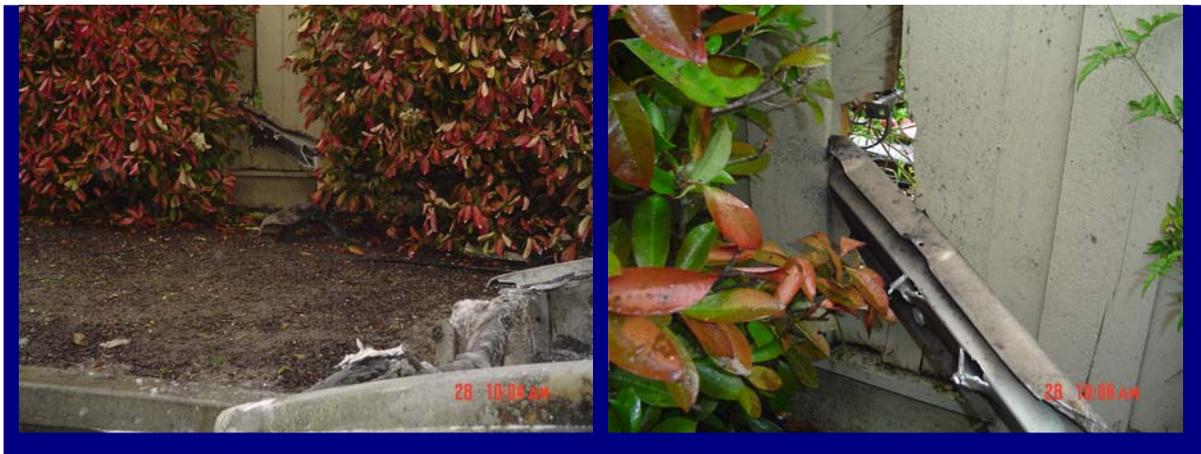
After the fire was knocked down Lieutenant Wenger found the bumper of the Volvo severely damaged and away from the vehicle. Further examination showed that the bumper was of the shock absorbing-type. The sealed components had pressurized and then failed, launching the bumper away from the vehicle penetrating the fence and coming to rest approximately twenty feet away. The bumper, weighing at least fifty pounds, traveled at a speed fast enough **not** to be seen by any of the three personnel standing less than ten feet away.

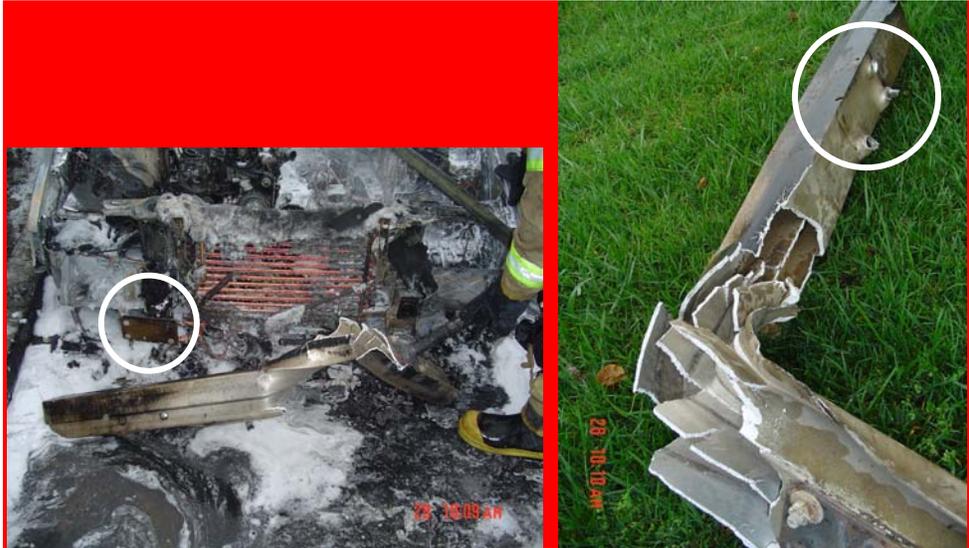
The bumper had departed from the vehicle at forty-five degrees from the passenger's side. As seen below only the driver's side shock failed. The bracket on the passenger's side secured the bumper for only long enough to change the flight path and cause the bumper to twist one hundred and eighty degrees from its original shape. Because one of the brackets held the bumper in place, energy from the explosion was utilized to twist the bumper and to shear three of the four bolts on the passenger's side of the car. Had both of the shocks failed simultaneously, or the bracket on the passenger's side been further damaged by the fire, the bumper would have traveled at a much greater force, possibly damaging the engine or seriously injuring personnel.

It is also worthy to note the obvious. If it had been the passenger's shock that had failed first there would be three seriously wounded Salinas Rural personnel as a result of this ordinary vehicle fire.

Text found in IFSTA Essentials in reference to fighting vehicle fires states, "...approach the vehicle from the front or rear corners." This is common practice generally used by most fire departments when fighting vehicle fires. Although this was an isolated incident, it would be prudent to approach vehicle fires between the front and rear tires (see picture below). This will guarantee there are no personnel standing in the flight path of any projectiles from the front or back of the vehicle. Prior making this approach ensure that all traffic hazards have been eliminated.

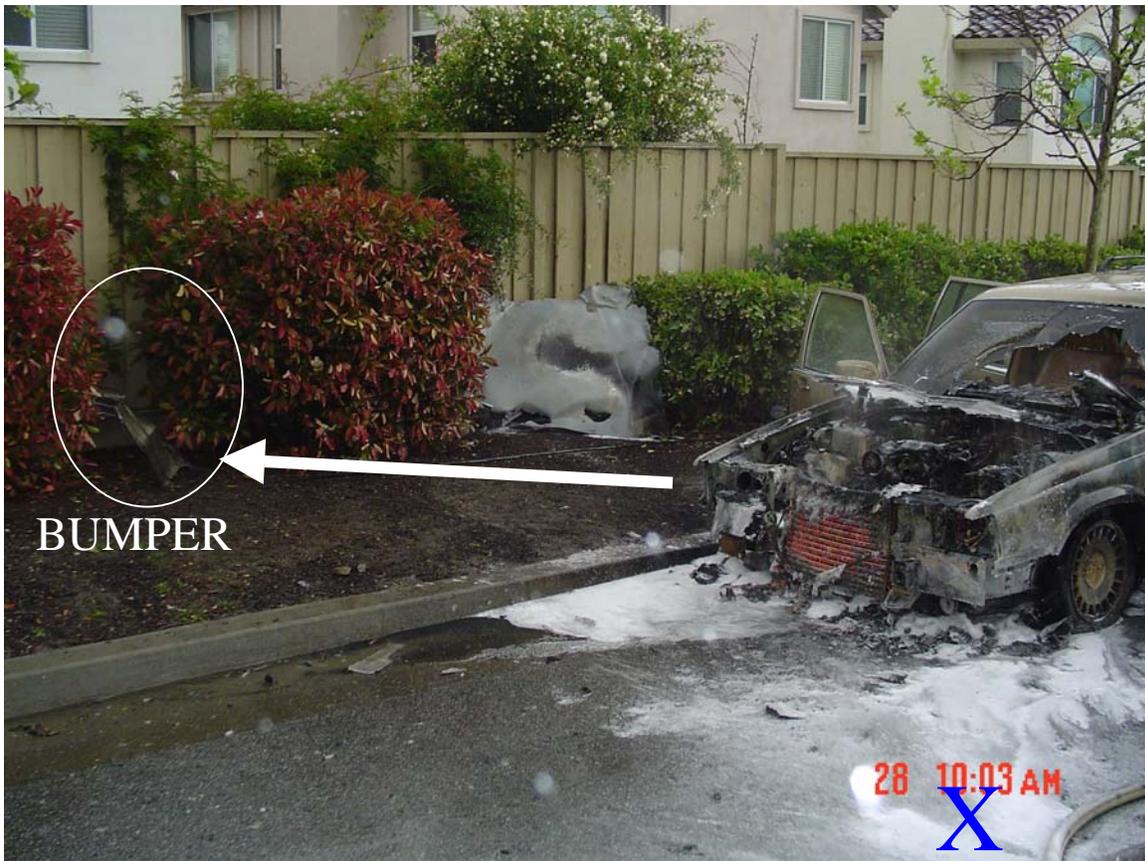
X Location of Salinas Rural Personnel at the time of failure.
