SALINAS RURAL FIRE DISTRICT TAILBOARD SAFETY SESSION APRIL, 2005

Vehicle Fires & Projectiles

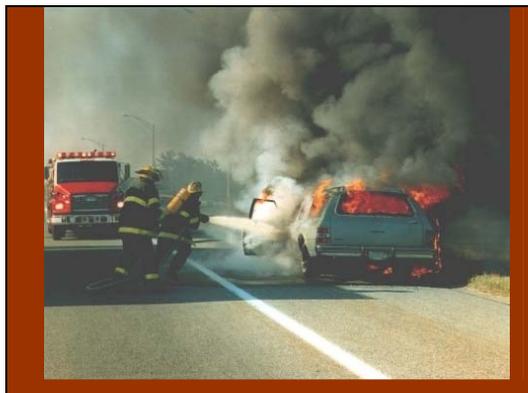
After the fire was knocked down Lieutenant Wenger found the bumper of the Volvo severely damaged and away from the vehicle. Further examination showed that the bumper was of the shock absorbing-type. The sealed components had pressurized and then failed, launching the bumper away from the vehicle penetrating the fence and coming to rest approximately twenty feet away. The bumper, weighing at least fifty pounds, traveled at a speed fast enough **not** to be seen by any of the three personnel standing less than ten feet away.

The bumper had departed from the vehicle at forty-five degrees from the passenger's side. As seen below only the driver's side shock failed. The bracket on the passenger's side secured the bumper for only long enough to change the flight path and cause the bumper to twist one hundred and eighty degrees from its original shape. Because one of the brackets held the bumper in place, energy from the explosion was utilized to twist the bumper and to shear three of the four bolts on the passenger's side of the car. Had both of the shocks failed simultaneously, or the bracket on the passenger's side been further damaged by the fire, the bumper would have traveled at a much greater force, possibly damaging the engine or seriously injuring personnel.

Text found in IFSTA Essentials in reference to fighting vehicle fires states, "...approach the vehicle from the front or rear corners." This is common practice generally used by most fire departments when fighting vehicle fires. Although this was an isolated incident, it would be prudent to approach vehicle fires between the front and rear tires (see picture below). This will guarantee there are no personnel standing in the flight path of any projectiles from the front or back of the vehicle. Prior making this approach ensure that all traffic hazards have been eliminated.
